The Identification of Metal Transfer From Bullets onto Laminated Glass

John Chester

Indiana State Police Laboratory, Microanalysis Unit, Indianapolis, Indiana 46202

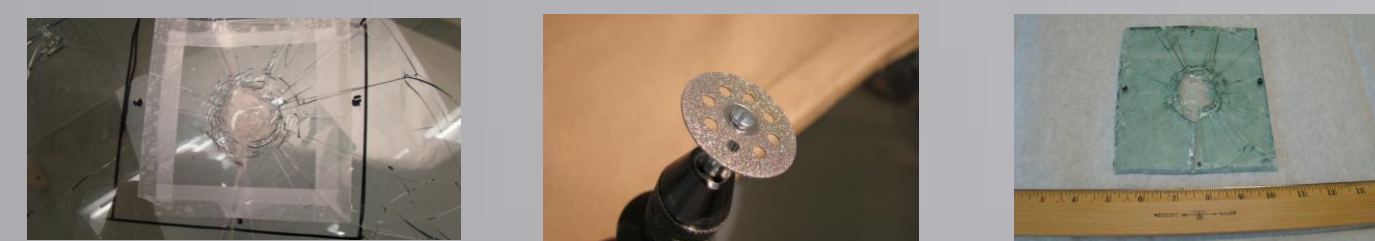
8 windshields were donated by Safelite AutoGlass. A wooden frame was constructed to hold the windshields in place. The ISP firearms unit fired 3 shots from various firearms and ammunition through the windshields. One area of impact was selected and cut out of each windshield using a Dremel Tool equipped with a blade coated in Diamond dust.

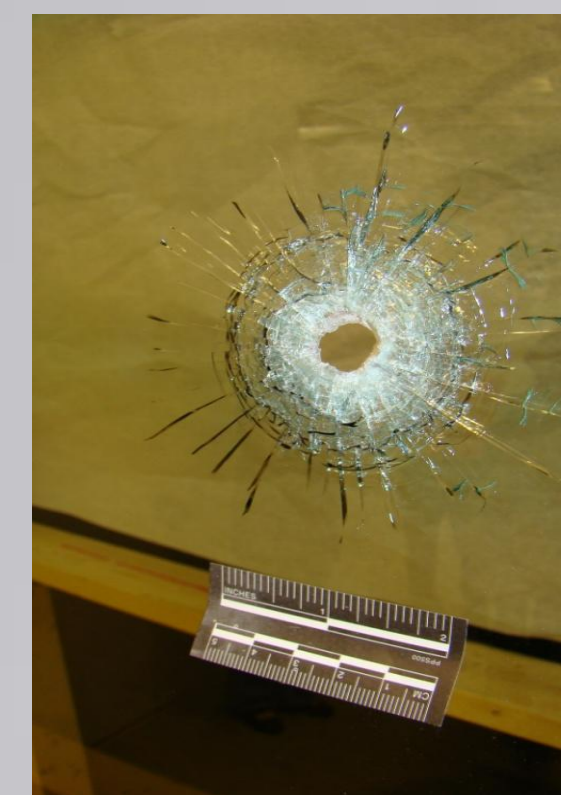
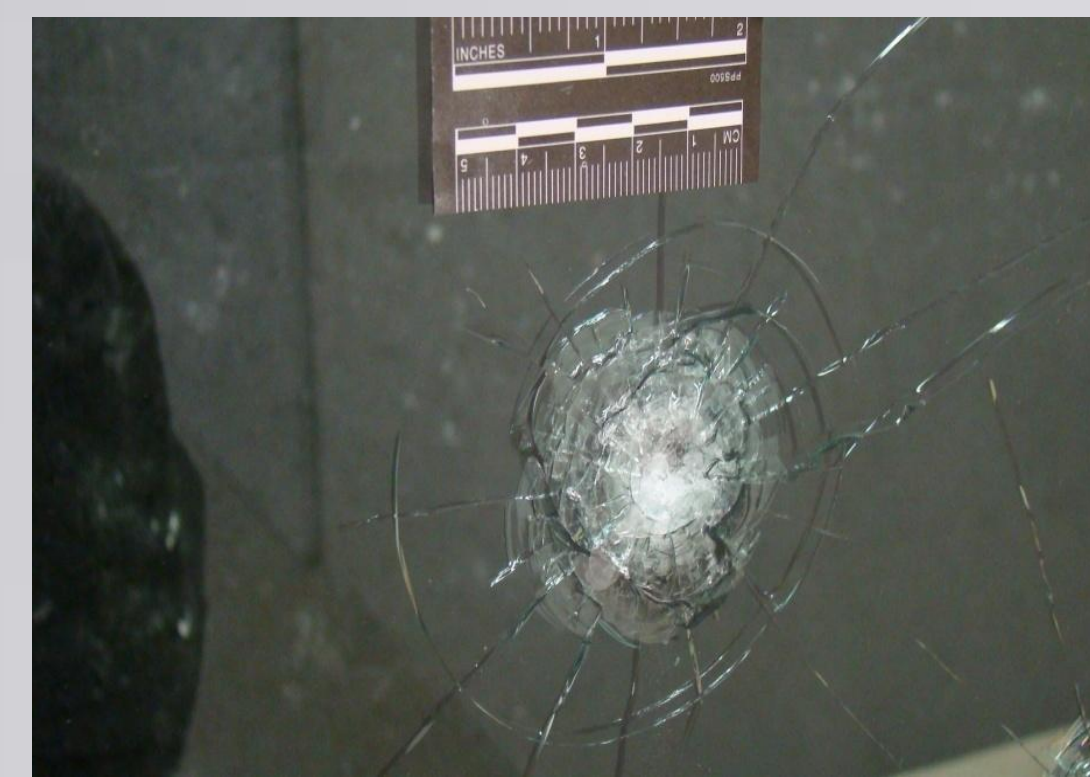
From these images could you determine if the impacts shown are consistent with originating from a bullet or something else? How would you explain your conclusion?

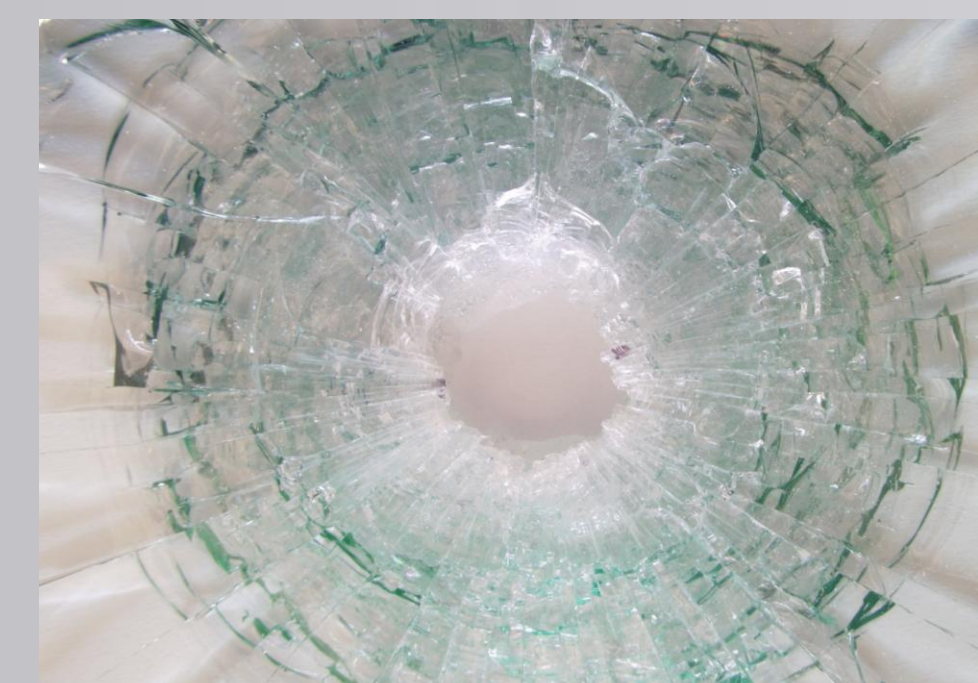
Windshield section with a lead metal transfer

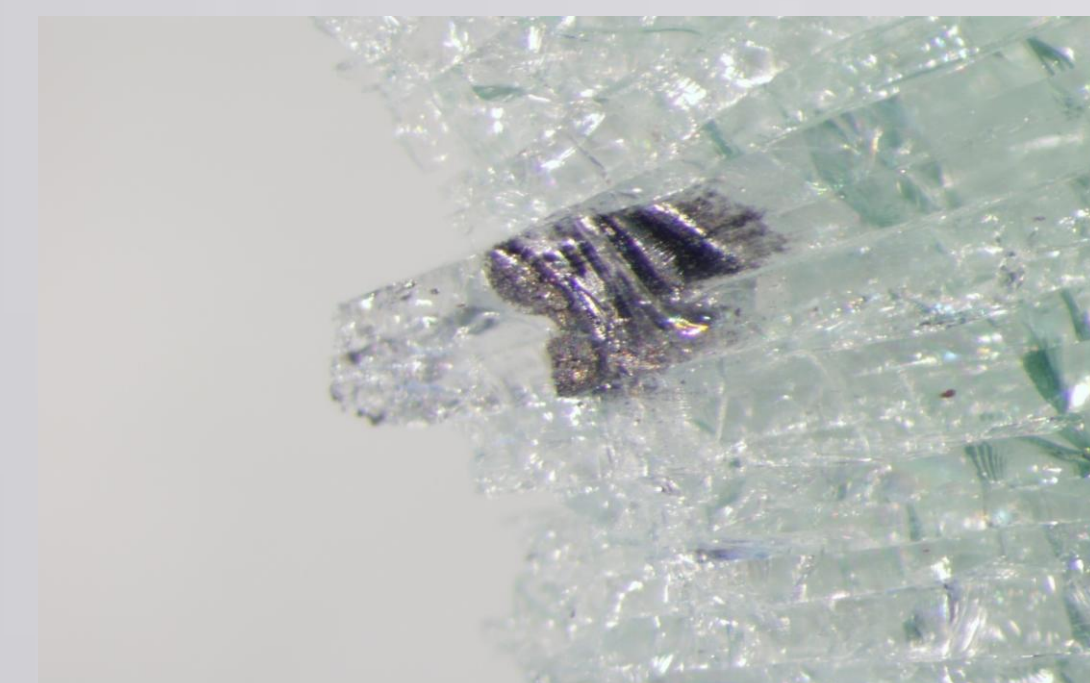
Microscopic lead metal transfer

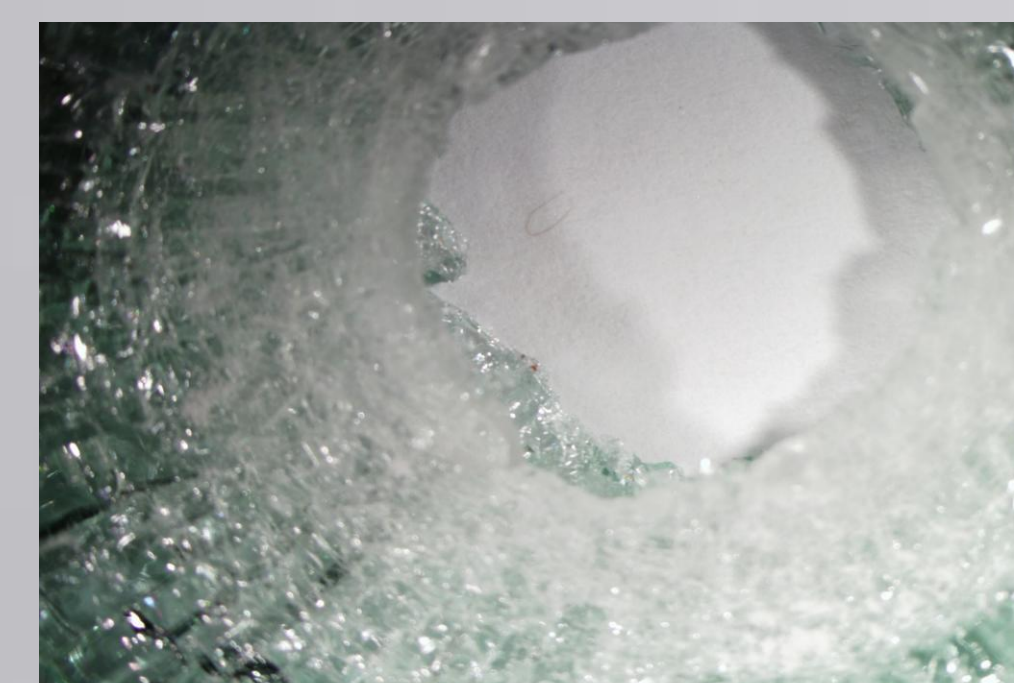
Windshield section with a copper metal transfer

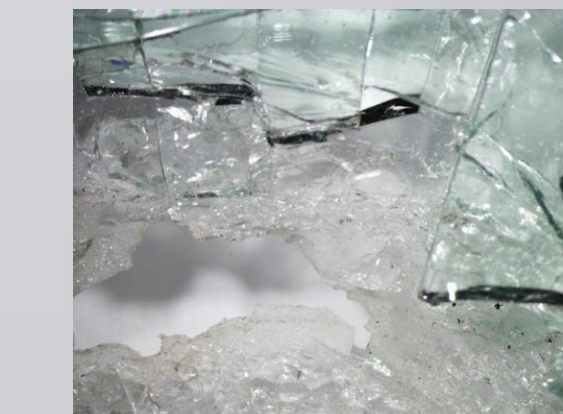
Elemental analysis of the cut out area of impact of the windshield revealed the presence of several areas containing lead metal. These areas of the windshield have come into contact with an object containing lead metal.

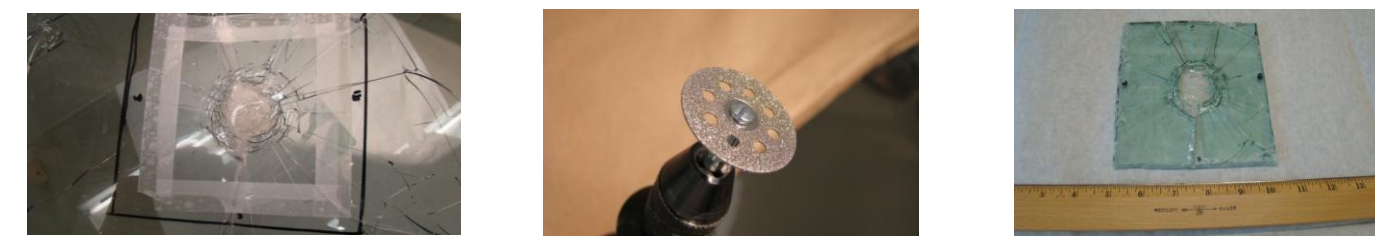
8 windshields were donated by Safelite AutoGlass. A wooden frame was constructed to hold the windshields in place. The ISP firearms unit fired 3 shots from various firearms and ammunition through the windshields. One area of impact was selected and cut out of each windshield using a Dremel Tool equipped with a blade coated in Diamond dust.

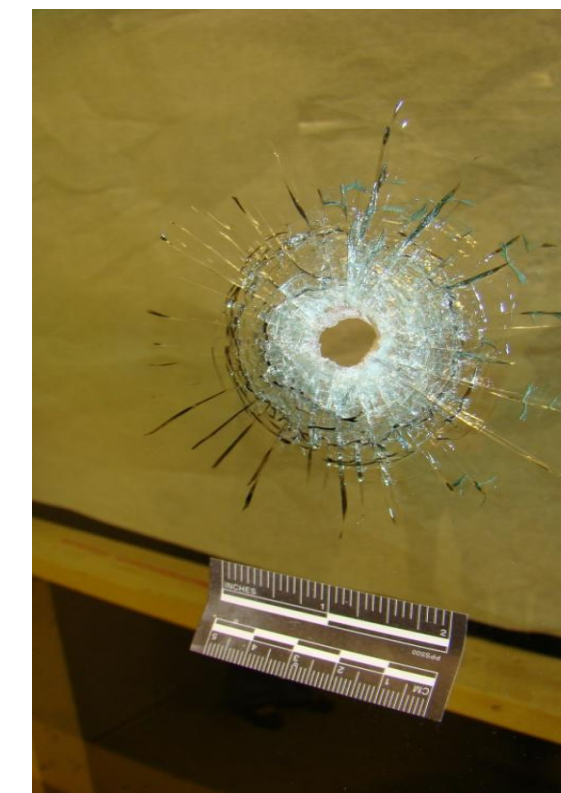
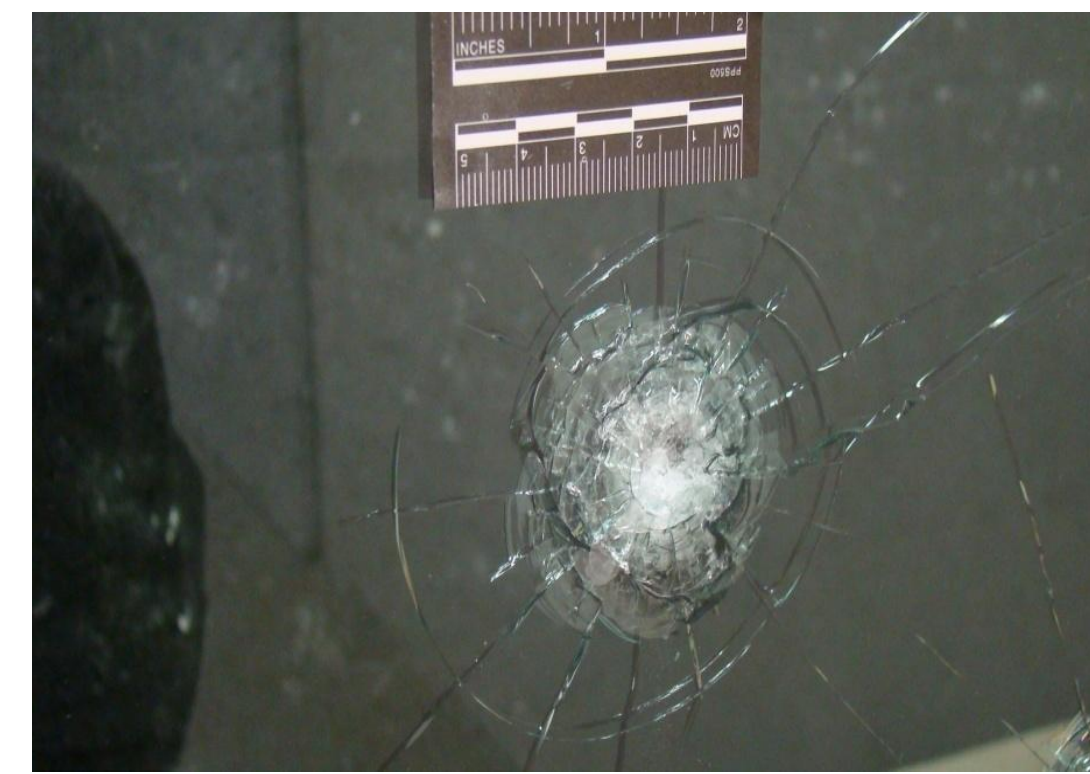
From these images could you determine if the impacts shown are consistent with originating from a bullet or something else? How would you explain your conclusion?

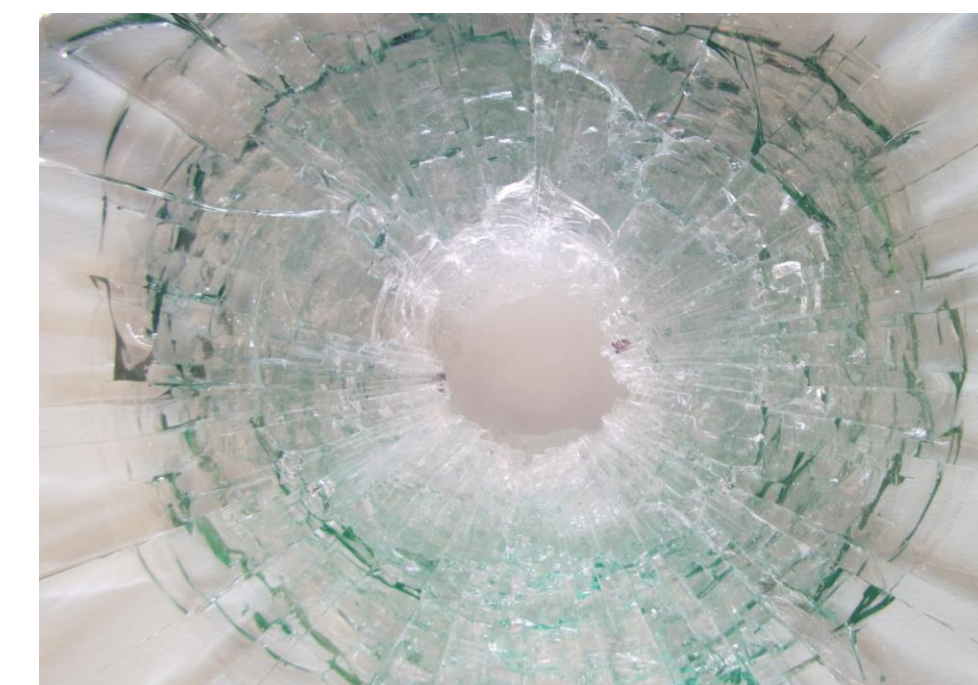
Windshield section with a lead metal transfer

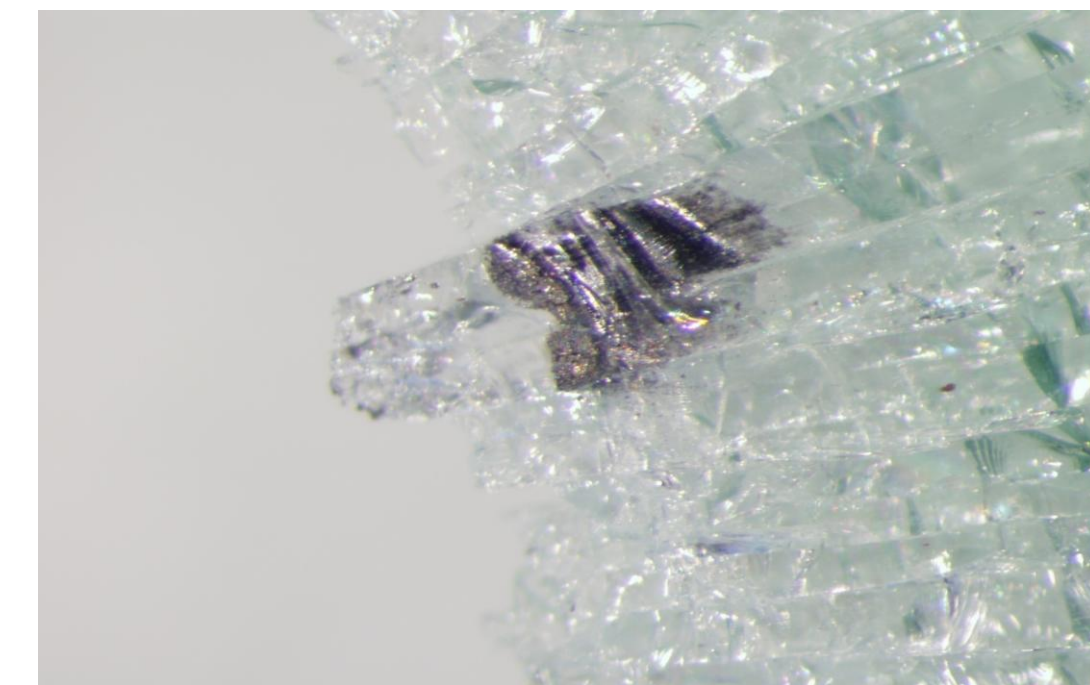
Microscopic lead metal transfer

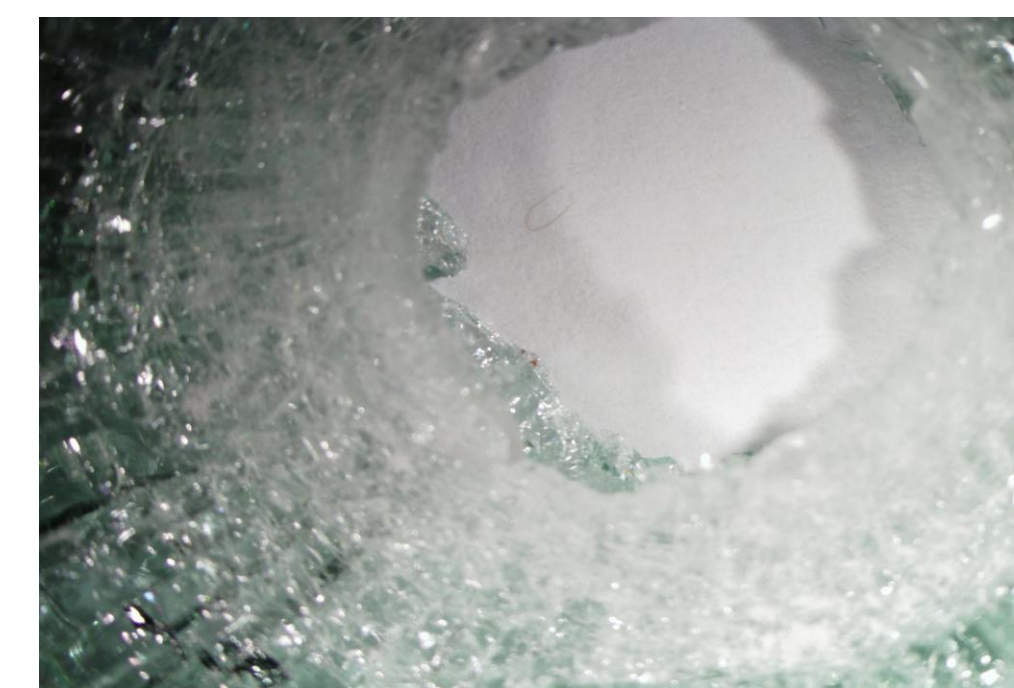
Windshield section with a copper metal transfer

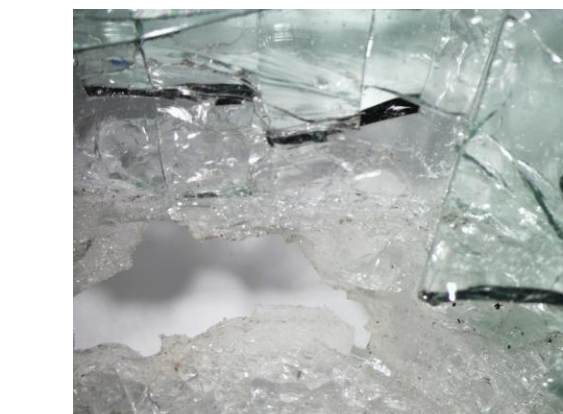
Elemental analysis of the cut out area of impact of the windshield revealed the presence of several areas containing lead metal. These areas of the windshield have come into contact with an object containing lead metal.
