Bang! Goes the Airbag

Using Dust from Deployed Airbags as Trace Material in Automotive Crimes

Dr. Louissa Marsh Trace Evidence Symposium August 2011 Kansas City, Missouri

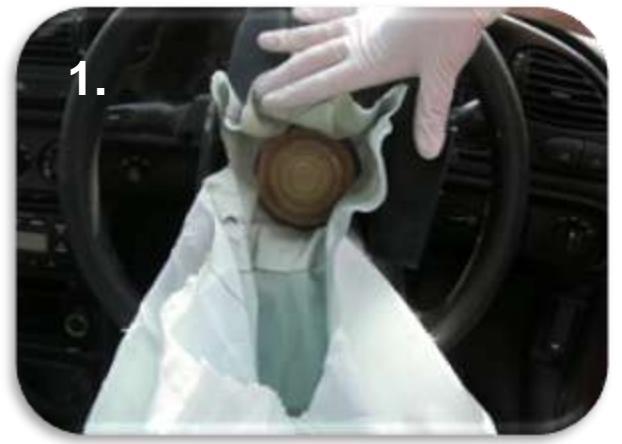
1. Airbag deployed and half removed

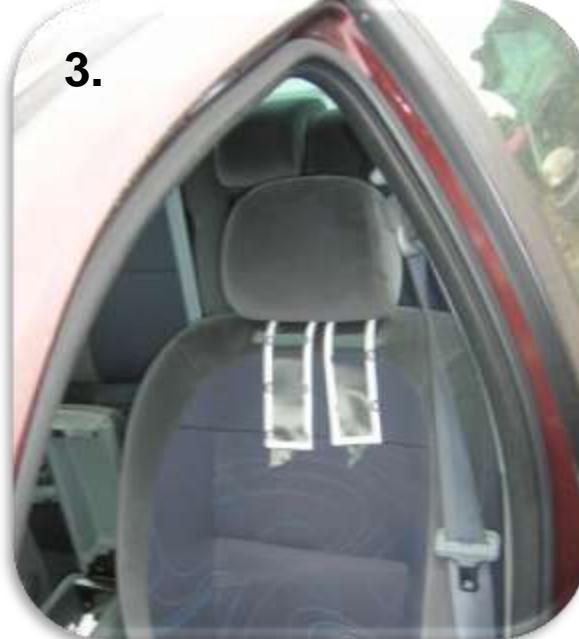
3. Open tape lifts on back of driver and passenger seats, left insitu during deployment

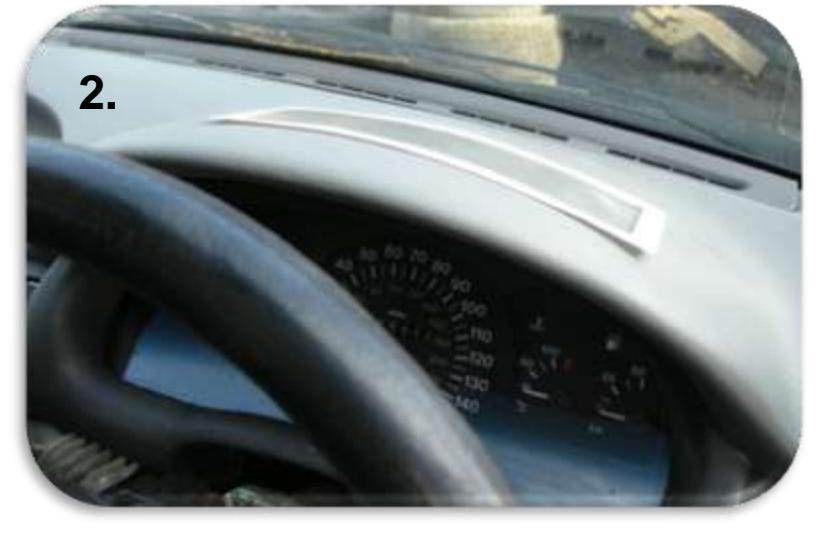
2. Open tape lift on back of steering wheel, left in-situ during deployment

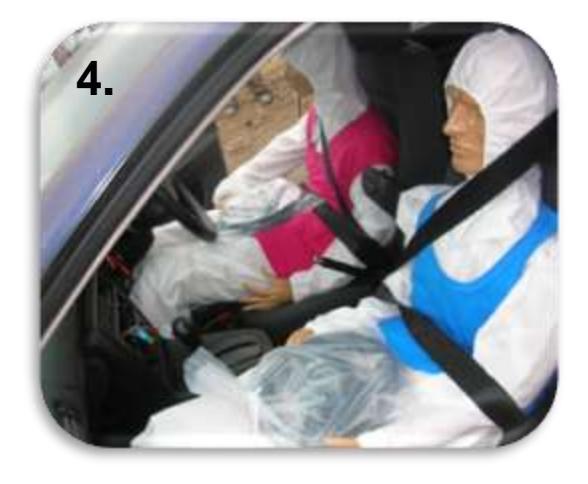
4. Dummies dressed in tshirts and weighed down, left insitu during deployment

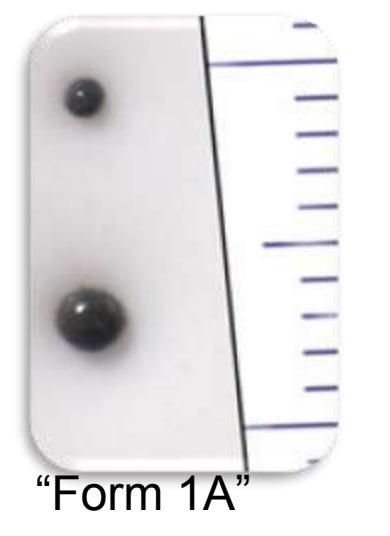
Smooth spherical particlesDark grey in colour

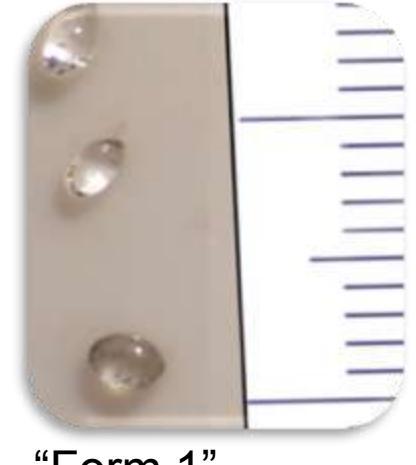
"Form 1"

- •Clear spherical particles
- •Some tear-drop shaped
- •Some with 'tails'
- •Has internal air bubbles
- Does not fluoresce

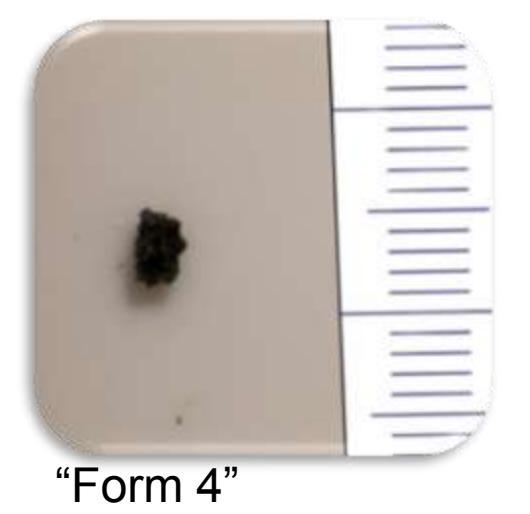
Dark grey/black powder like clumps
Breaks very easily difficult to pick up and move
Has internal air bubbles
Does not fluoresce

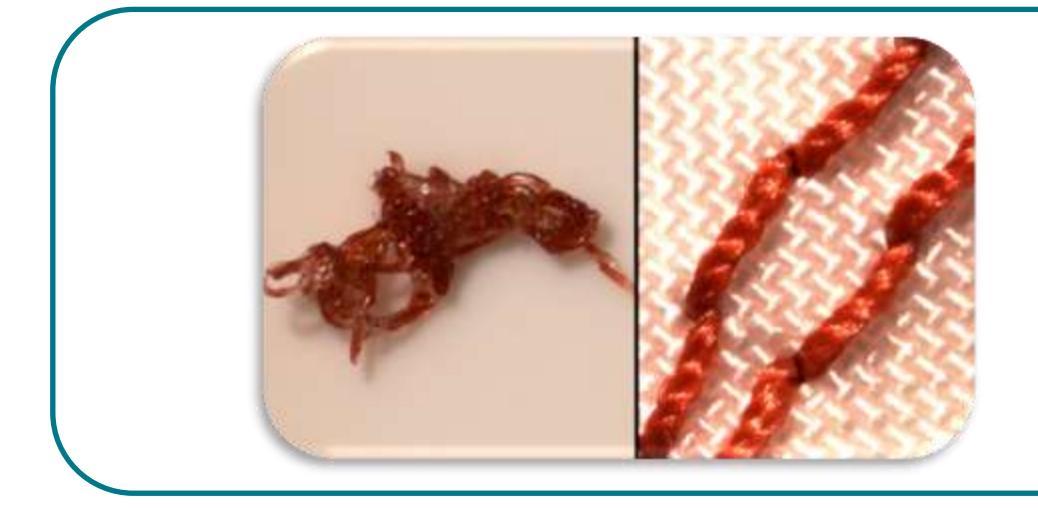
Volkswagen Vento Red stitching red worms

- different airbag dust, but in each and every airbag, the forms seen and their ratios varied
- 'Worms' which were glass-like forms were seen from almost every airbag. Many of these were coloured- red, green, blue, pink, black, and there seems a good correlation between the colour of the stitching on the airbag and the worm colours
- Initial, preliminary results indicate that the dust reaching the passenger seat during detonation of a driver's airbag is approximately half the amount which reaches the driver's seat The presence of a lining on the airbag- although debris was reduced, at least 1/2 teaspoon of debris was recovered from each airbag

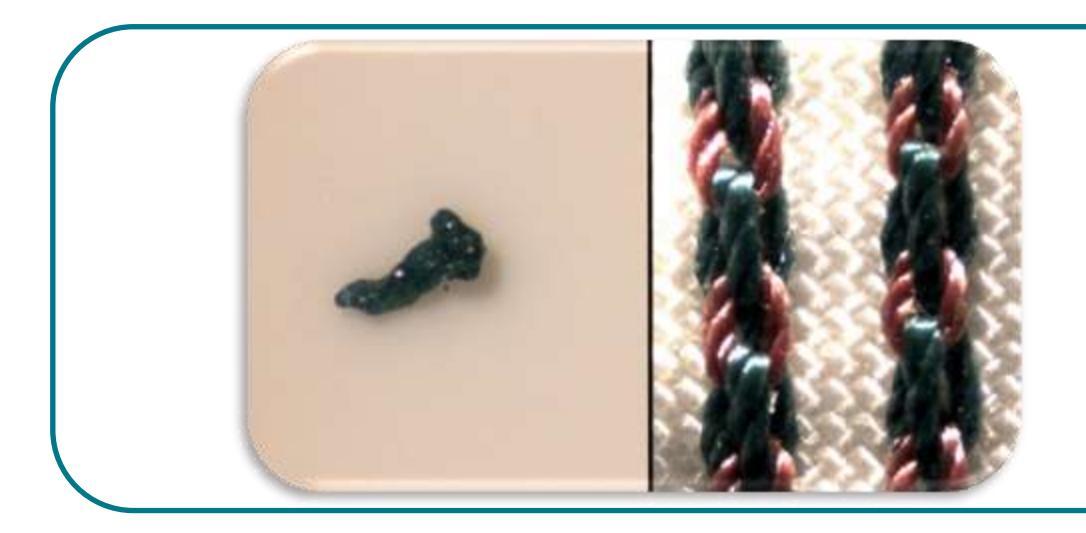
Volkswagen Vento Green stitching green worms

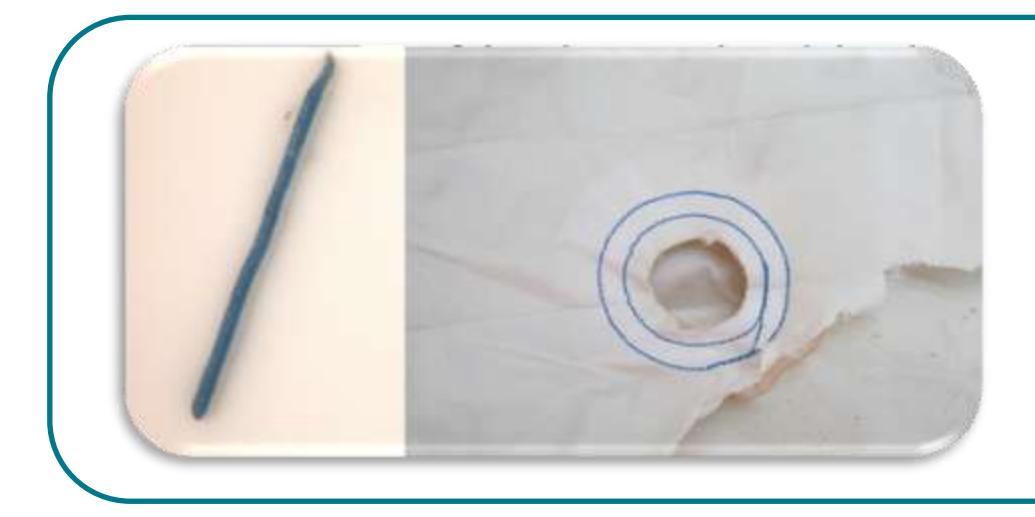
Toyota Celica blue stitching blue worms

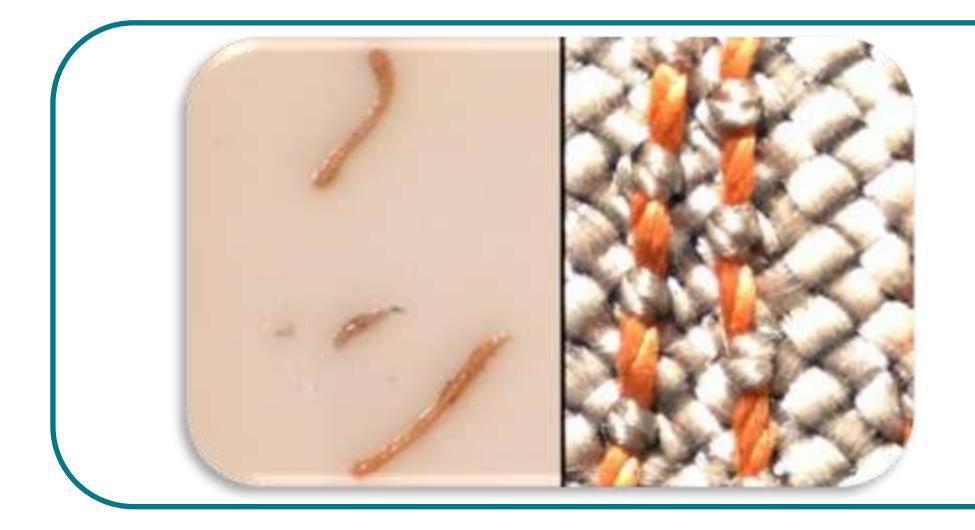
Vauxhall Cavalier Orange stitching orange worms

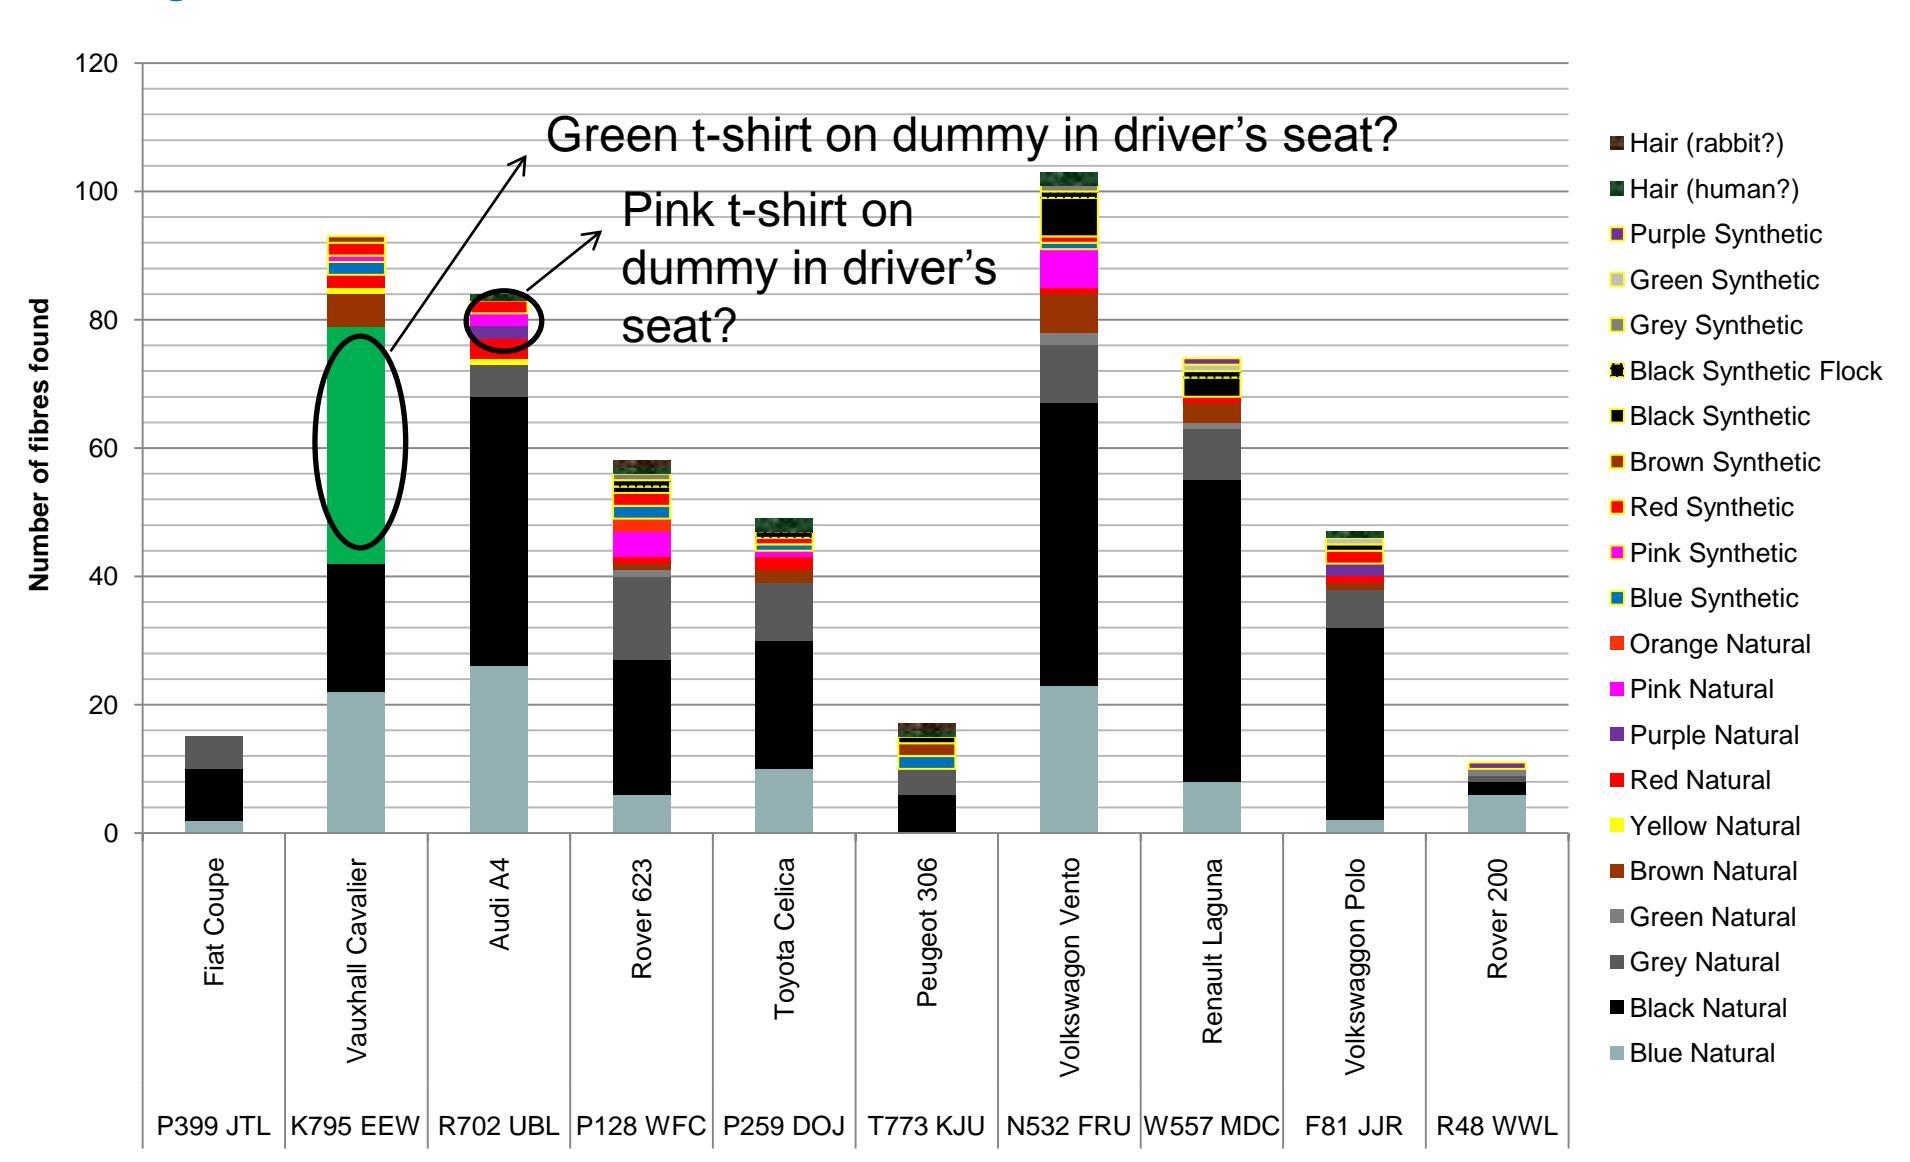
Fibres recovered from the surface of the deployed airbag before removal

- A significant number of fibres were recovered from the surfaces of the recently deployed airbags- although most were 'background' grey, black and blue, care should be taken when placing significance onto the finding of matching fibres
- If a passenger and a driver's airbag have deployed, the dust produced from each may have similar forms. As dust was found to be distributed around the front of the vehicle, it would not be possible to differentiate where a person was sitting in the vehicle by the finding of dust on clothing alone.
- The distinctive forms show signs of heating and melting, with little birefringence- typically what would be expected when material heats and cools rapidly without crystallisation being able to occur

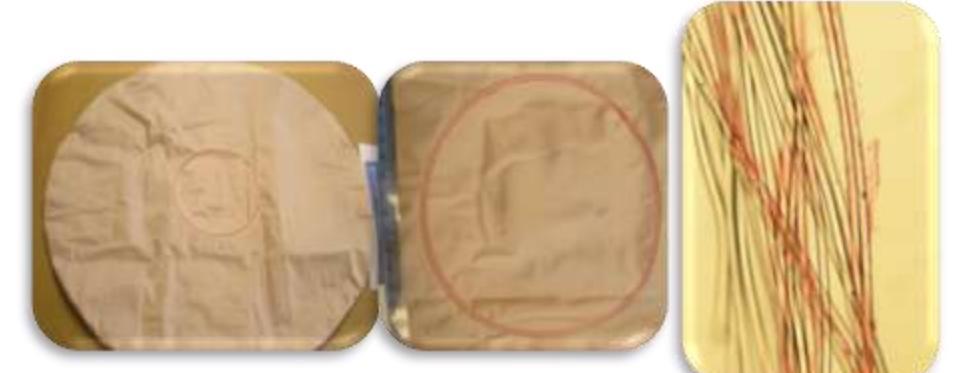
Item was a round, pink airbag with a red, stitched circle to the front. On the rear was a rough cut hole and the airbag was unlined. The material of the airbag was of a smooth, tight knit construction. There was some scorching seen on the inside, and a substantial quantity of debris was seen on the outside surface and also in the interior of the airbag.

The debris was grey in colour, ranging in size from 0.3mm to less than 0.1mm. The debris was very distinctive, found to be soft when squashed, and fairly shiny in

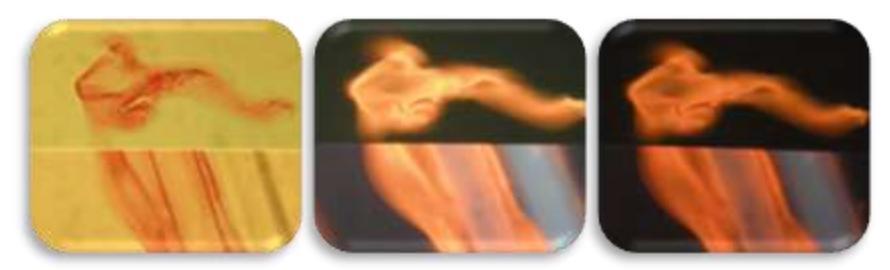
One particle of pink/red thin plastic, recovered from the jacket and compared x500 (left- white light, middle- blue 'light', right- UV 'light') to the airbag stitching & found to match.

Tested fragments from the jacket were optically indistinguishable from airbag particles (x500 by bright field, dark field, polarising transmitted light and for their fluorescent properties.

EDX analysis found that four of the five tested particles from the jacket were chemically similar to the particles from the airbag
